NASA TM-82461

SPACE SHUTTLE STS-1 SRB DAMAGE INVESTIGATION
FINAL REPORT

By Clyde D. Nevins
Structures and Propulsion Laboratory

January 1982

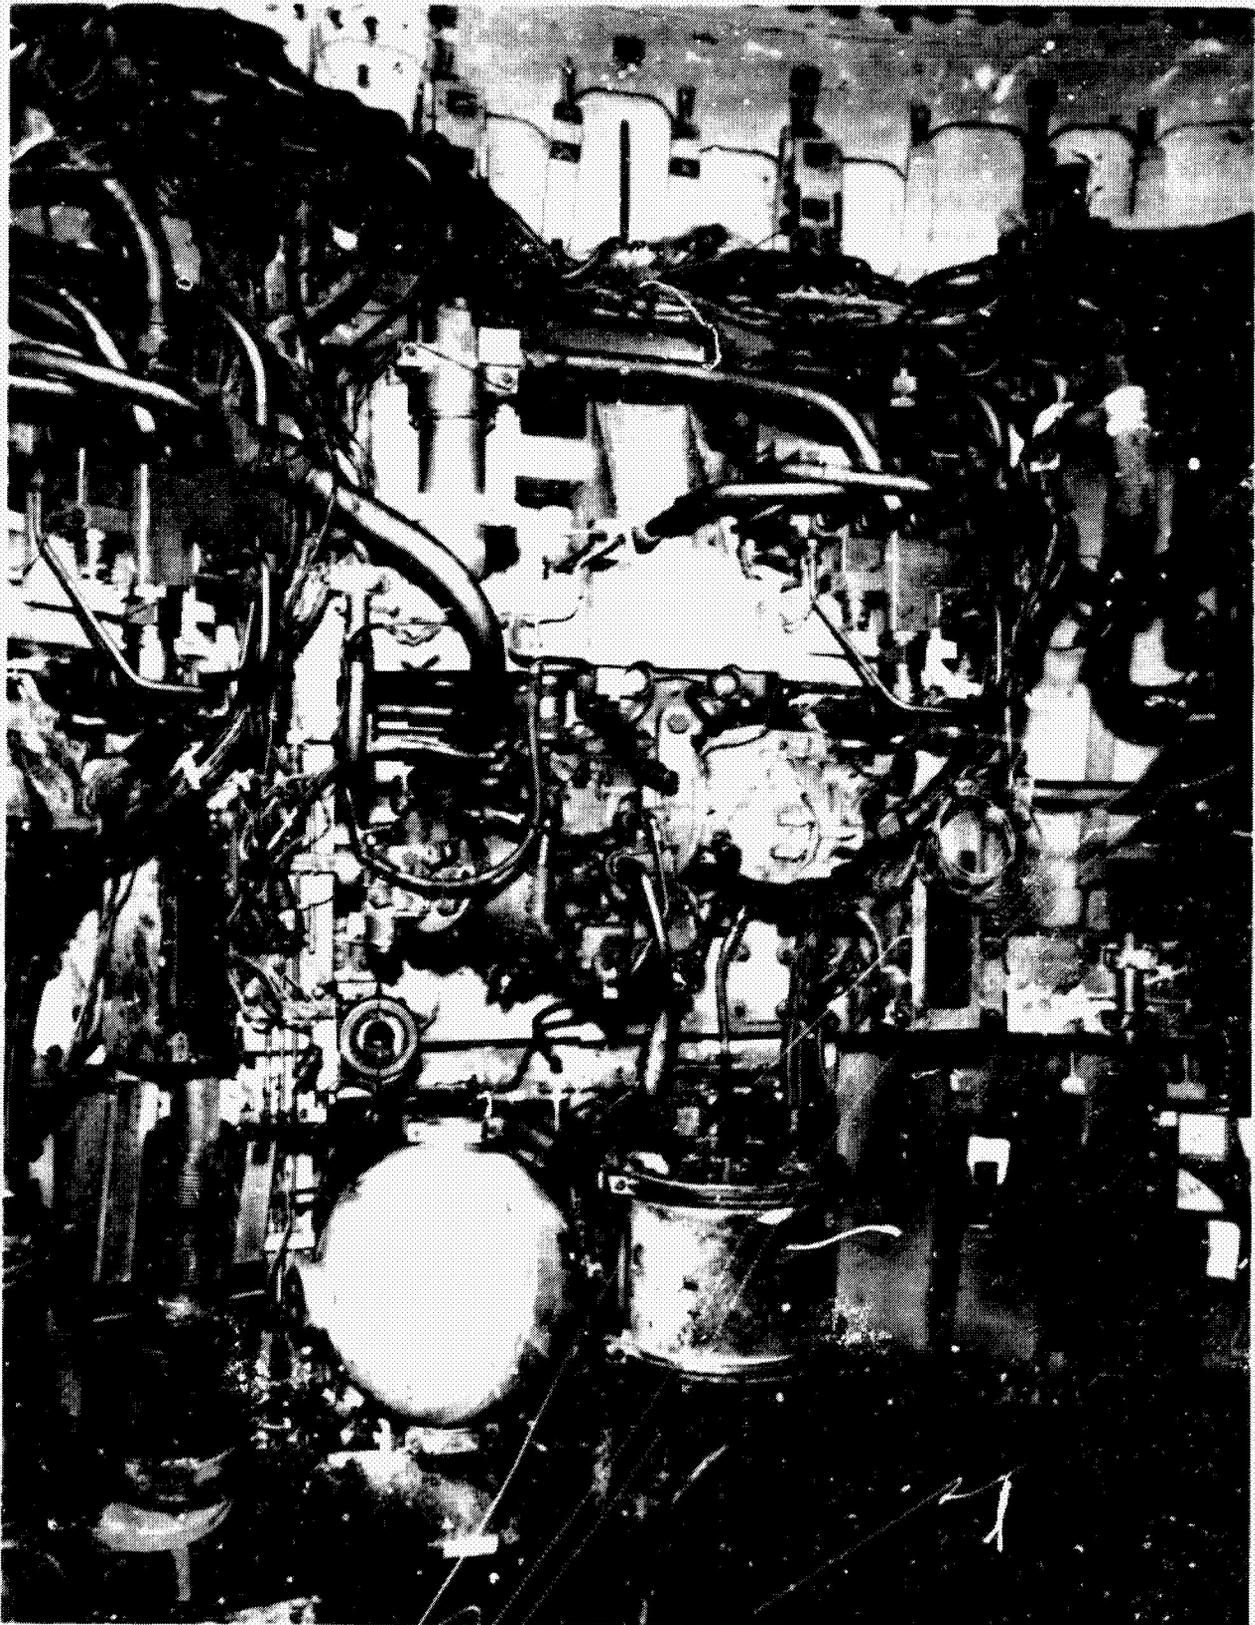
1. Cable Damage. A general inspection of electrical cabling was performed before removal [2,3], and a series of photographs were taken to record the damage. Figure 1 shows one such photograph taken of the A08 cabling prior to removal. In general, all cabling below the forwardmost ring showed some thermal damage, while cables routed above this ring were undamaged. Both A07 and A08 booster cabling suffered substantial thermal damage with those in A08 being the more severely damaged.

b. A08 Cables. Cables in the right-hand booster suffered substantially more damage than those in the left-hand booster, although the damage was of the same type as seen on A07. The presence of a heavy coating of smoke residue on all interior surfaces made visual determination of fire damage difficult.

Figure 1. A08 aft skirt cable damage.

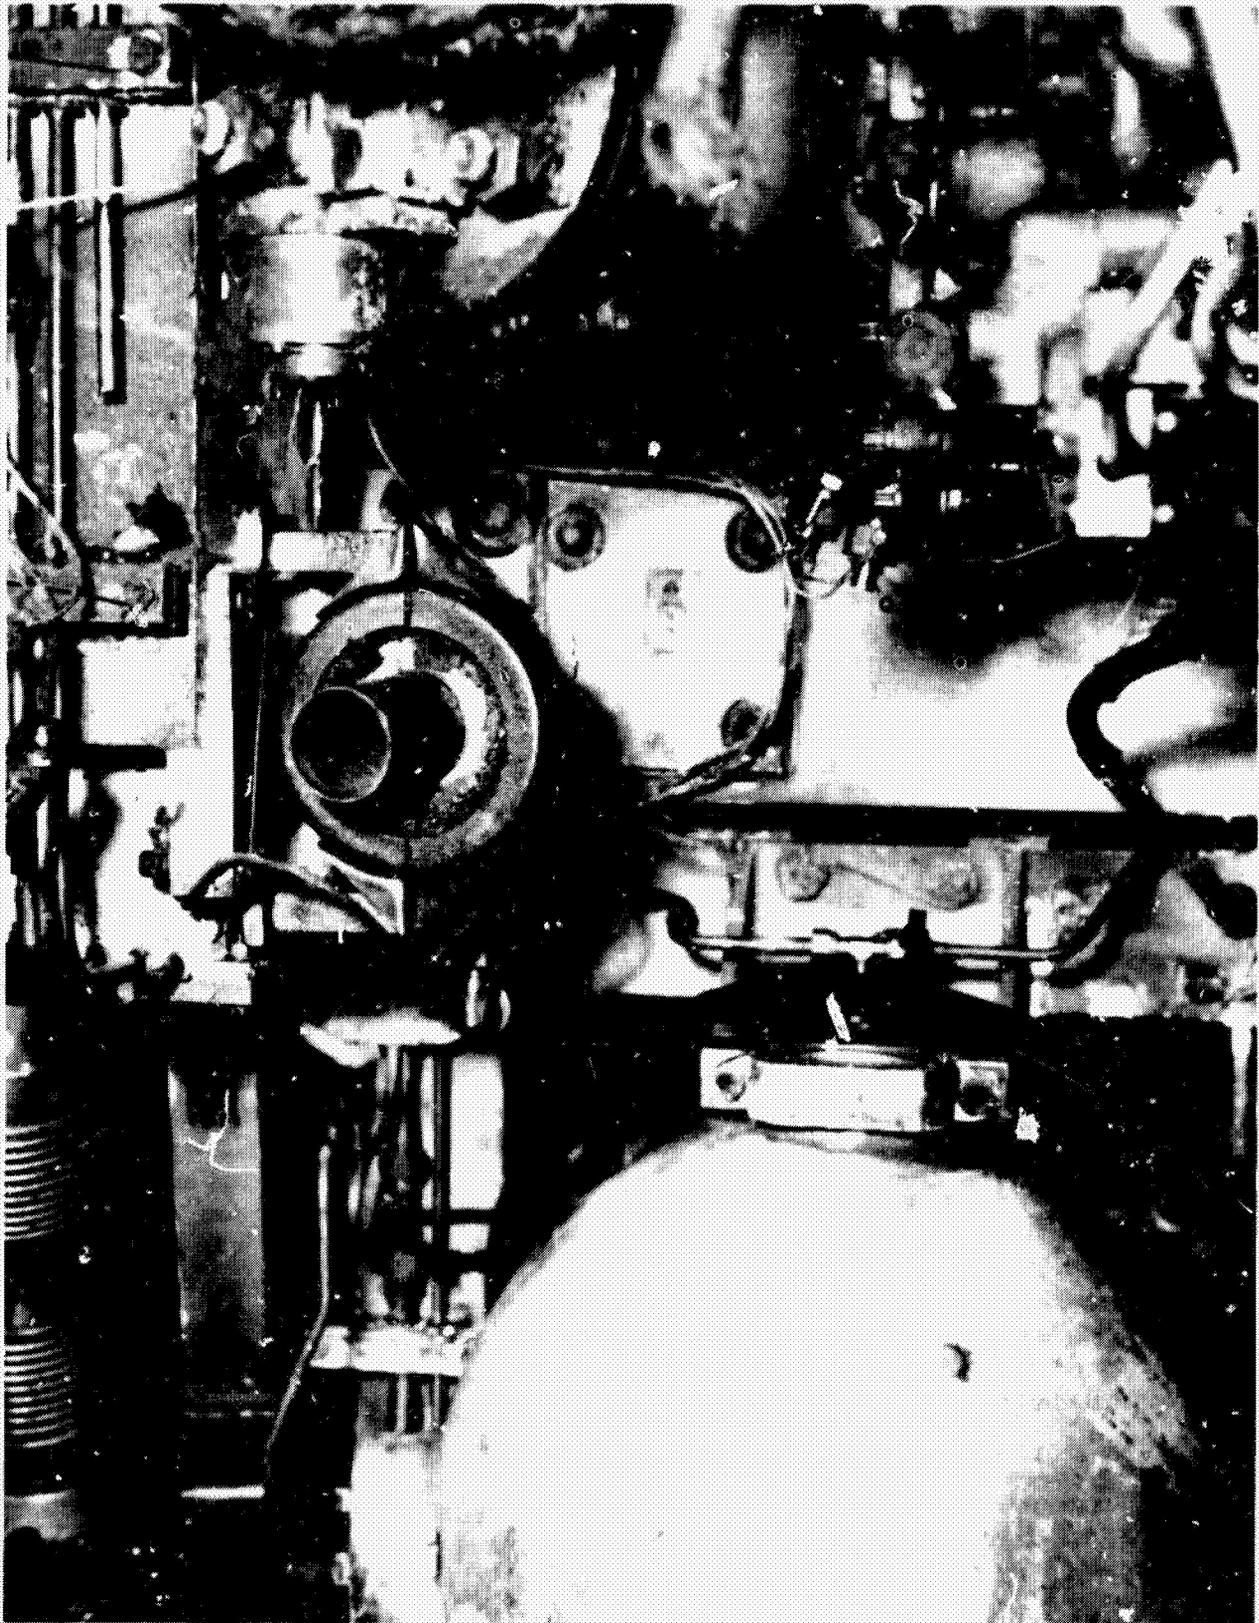
2. TVC Damage. There was a substantial difference in TVC damage between the LH (A07) booster and the RH (A08) booster [4]. The dual auxiliary power units and hydraulic power supplies ("tilt" and "rock") of A07 sustained mostly cosmetic damage, whereas the comparable A08 hardware was much more severely damaged. The greater A08 damage appeared to be the result of being exposed to either higher heating or a fire within the aft skirt cavity.

Figure 2. A08 VC subsystem damage.

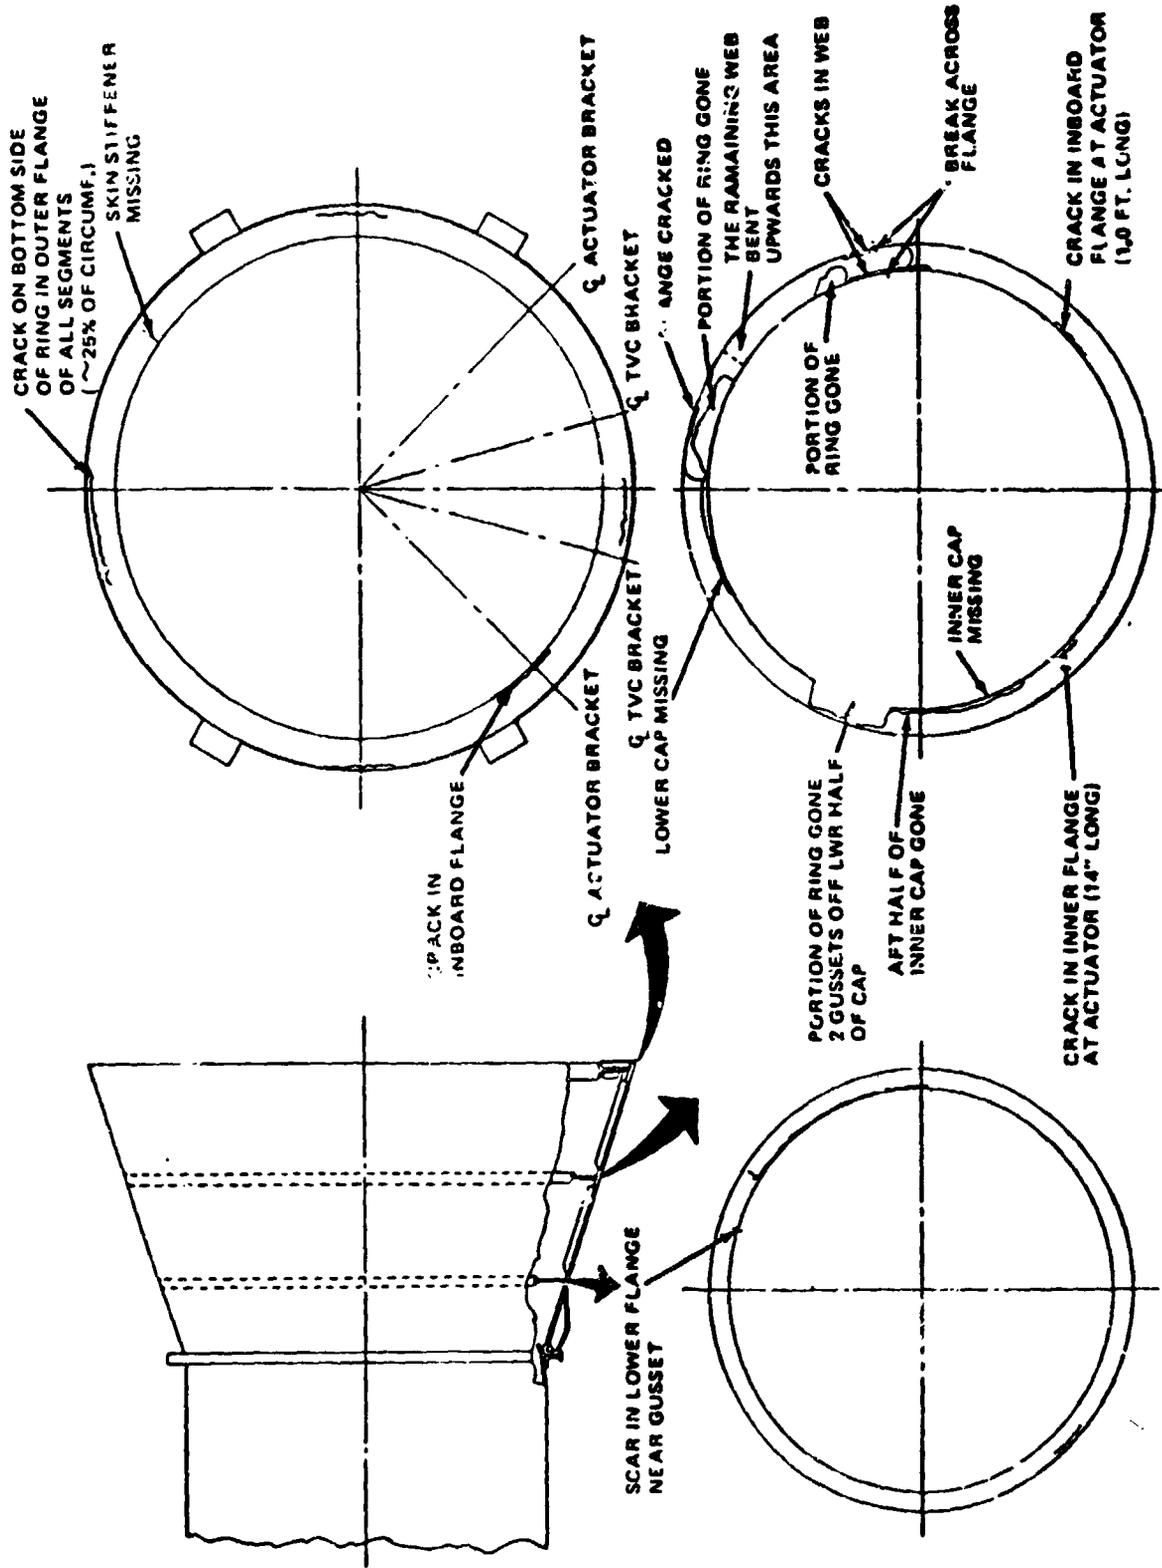
Figures 3 and 4 chart the specific damage received by A07 and A08 aft skirts, respectively. This damage is further described below.

1. Rings. The most obvious and perhaps the most significant SRB damage was sustained by the structural rings on the interior of the aft skirt. Damage was generally similar in both skirts, and this damage may be characterized as follows:

- a. Forward Ring. Local damage to the inboard aft side of the flange of the ring.
- b. Intermediate Ring. Severe damage to nearly all of the ring except that portion immediately behind the TVC subsystem.
- c. Aft Ring. Extensive cracking in the outer flange at the ring web.

Figure 3. STS-1 aft skirt damage (A07).

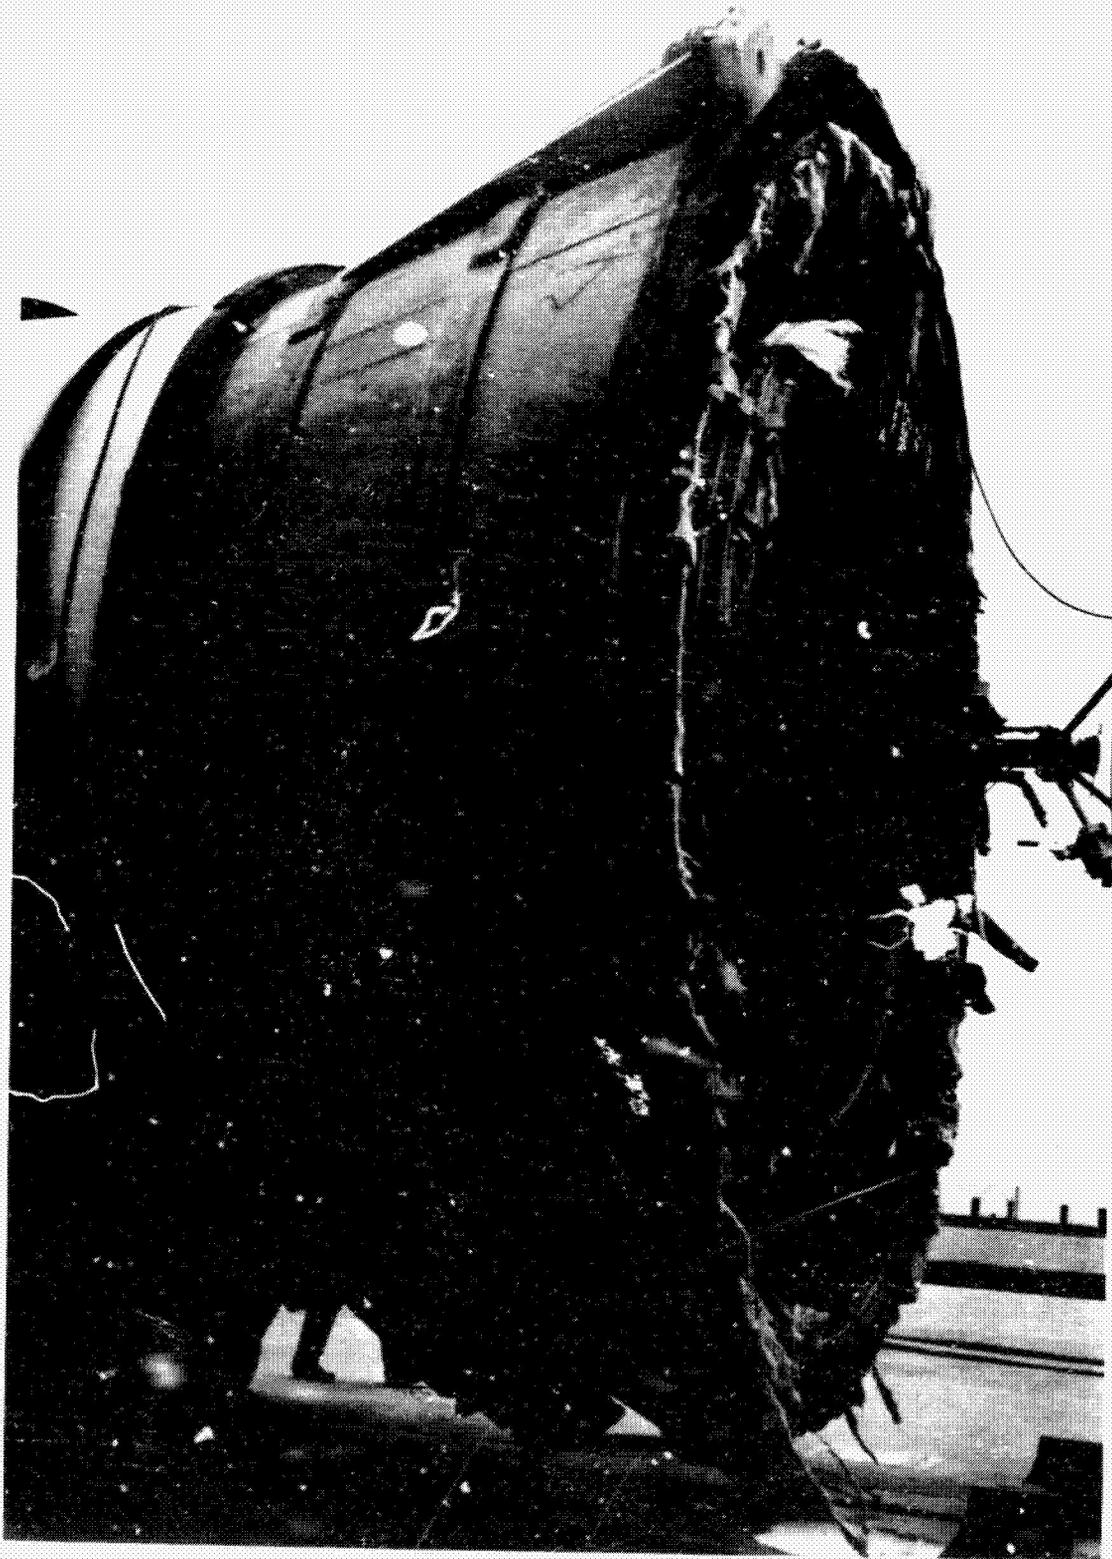
2. Thermal Curtain. As expected and per design intent, the thermal curtain was destroyed at the completion of the mission. The only remaining pieces of the thermal curtain were the shredded ends of the curtain segments under both the aft skirt and nozzle compliance ring retainers (Fig. 7). Also observed in the aft skirt area was that two thermal curtain retainers on the nozzle compliance ring were missing on each SRB and that these were missing prior to the reentry smudging of the aft skirt interior. These two retainers were immediately adjacent to the initiation point of the nozzle linear shaped charge. Figure 8 shows a view of the A08 nozzle compliance ring and shows the obvious discoloration of the paint due to reentry smoke. One other thermal curtain retainer segment was missing on the A07 compliance ring, located approximately 90 degrees counterclockwise from the nozzle initiation point (as viewed looking forward). The surface under this retainer segment, however, was clean, indicating the segment was lost after reentry smudging – presumably at water impact.

Figure 7. Thermal curtain remains.

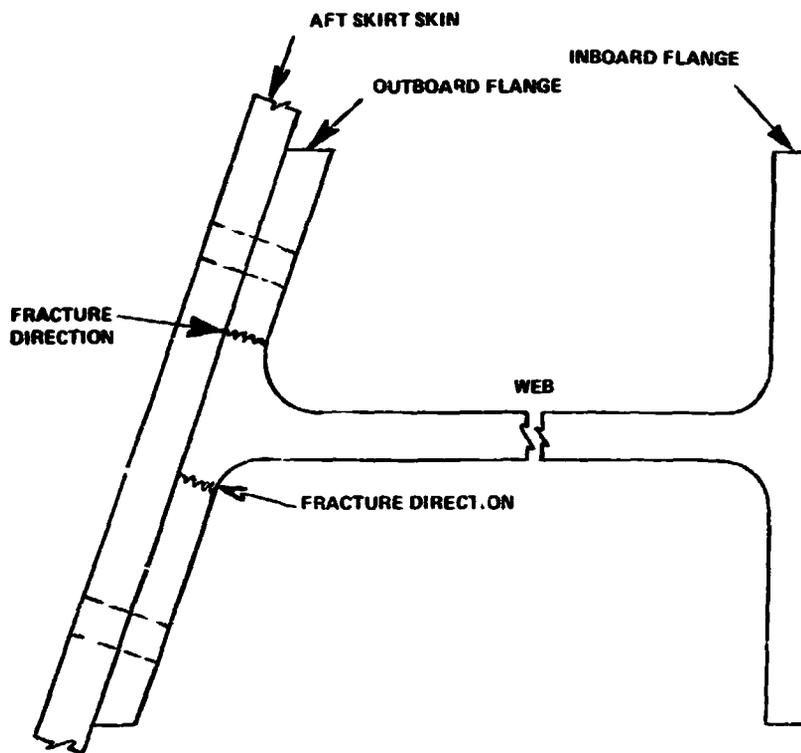
4. Failure Analyses of Rings. Visual, spectrographic, radiographic, metallographic, and fractographic analyses were performed on portions of the fractured ring segments for both the aft and intermediate rings of the A07 SRB [16,17].

Figure 24. Aft skirt intermediate ring fracture directions (A07).

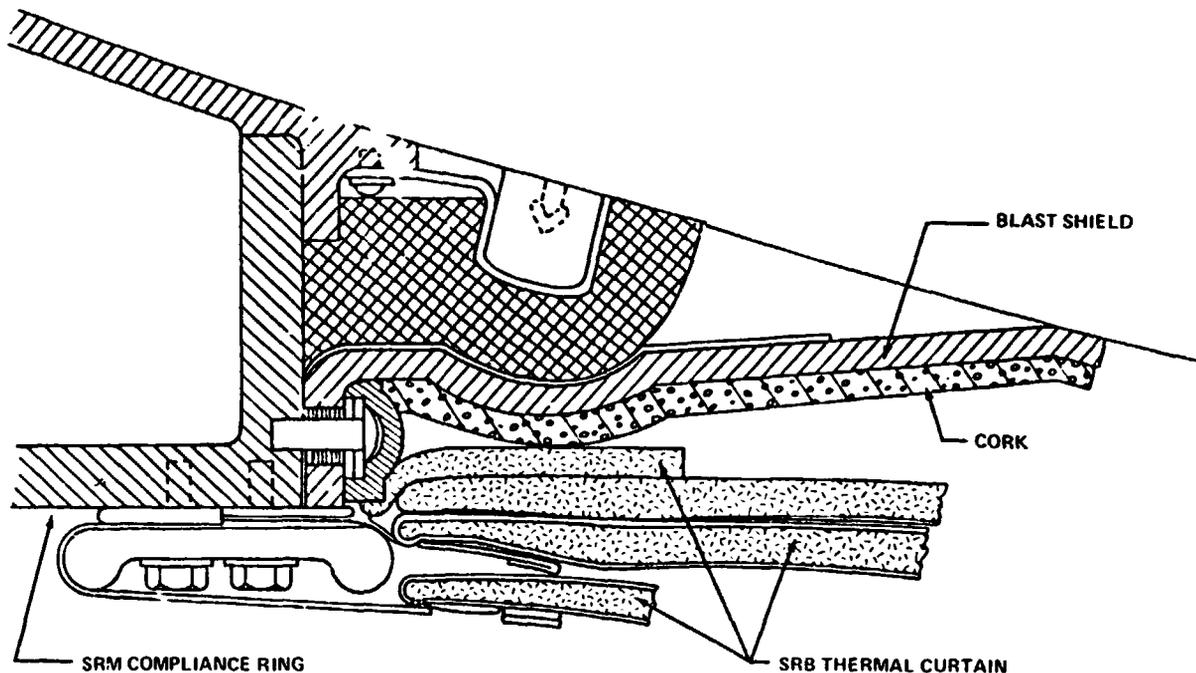
Failure of the SRB thermal curtain was precipitated, prior to reentry, by the initiation of the linear shaped charge (LSC) employed to jettison the SRM nozzle.²

Discussion. Thermal performance of the thermal curtain was nominal through the entire ascent heating regime (i.e., until after SRM burnout at 167 sec), but was almost totally lacking upon the earliest encounter with reentry aerodynamic heating. Two thermal curtain retainers at each SRM compliance ring interface were forceably detached prior to reentry smudging of the aft skirt interior surfaces [19]. The nozzle LSC is quite close to the thermal curtain retainers (Fig. 28), and problems with containing the blast without thermal curtain damage were experienced during static qualification firings of the SRM. The temperature rise recorded in the aft skirt cavity agrees quite well with preflight analyses for an assumed total loss of the thermal curtain at reentry [8].

Figure 28. Nozzle LSC in relation to thermal curtain retainers.
